Date: September 15, 2020

To: Jacolyn Thiel, PE, Public Service Director/City Engineer

From: John Swartzbaugh, PE  
Joshua Ford, PE

**Re: Summary Report on WIB Locations from 2020 Flooding Events**

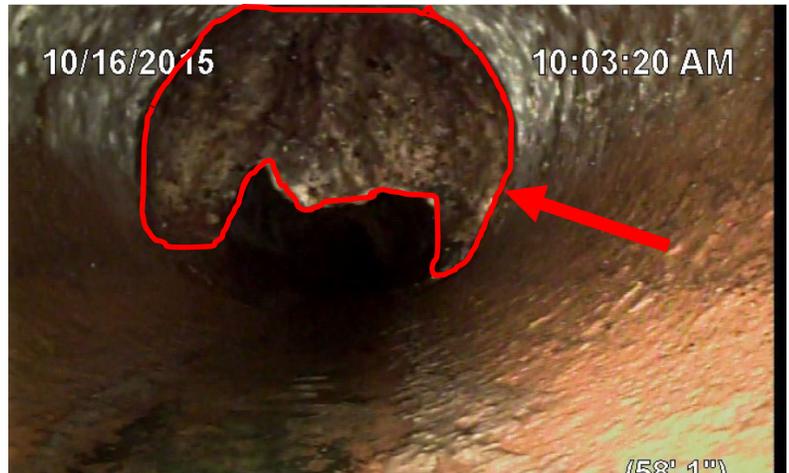
Mineral Deposit in Sanitary Lateral

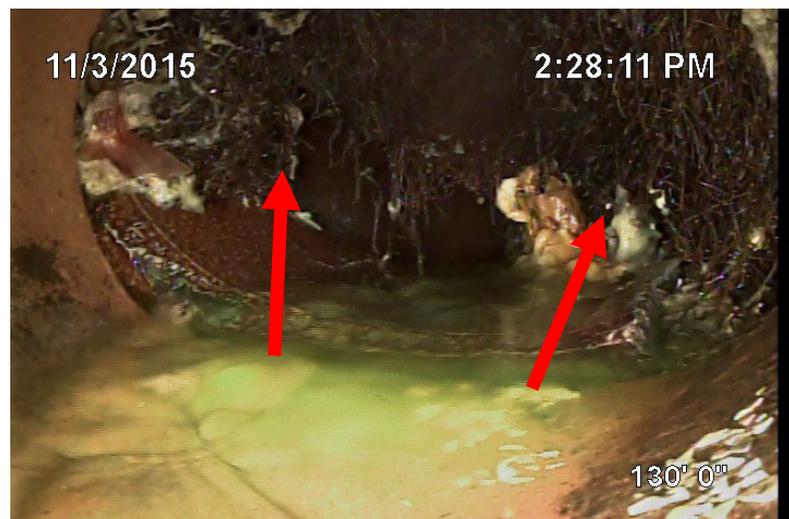
Roots in Sanitary Lateral

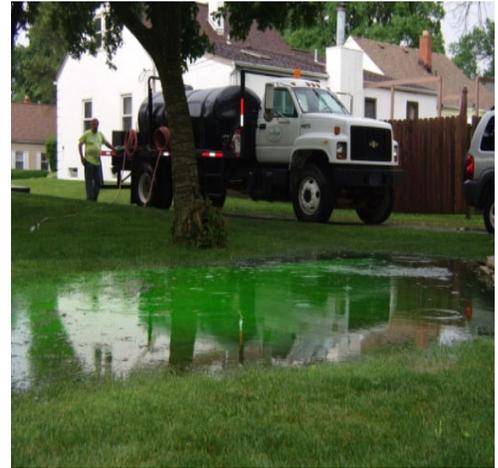
Ponding over sanitary sewer and sanitary lateral during rainfall simulation

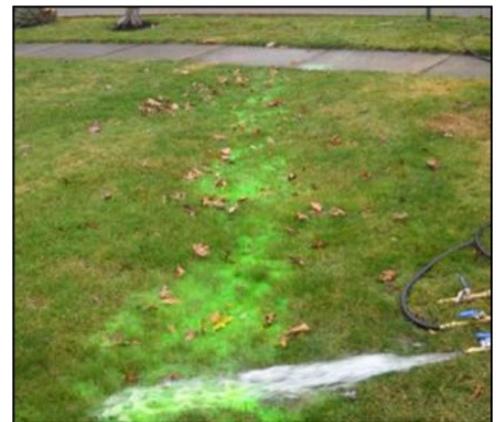
Ponding over sanitary lateral during rainfall simulation

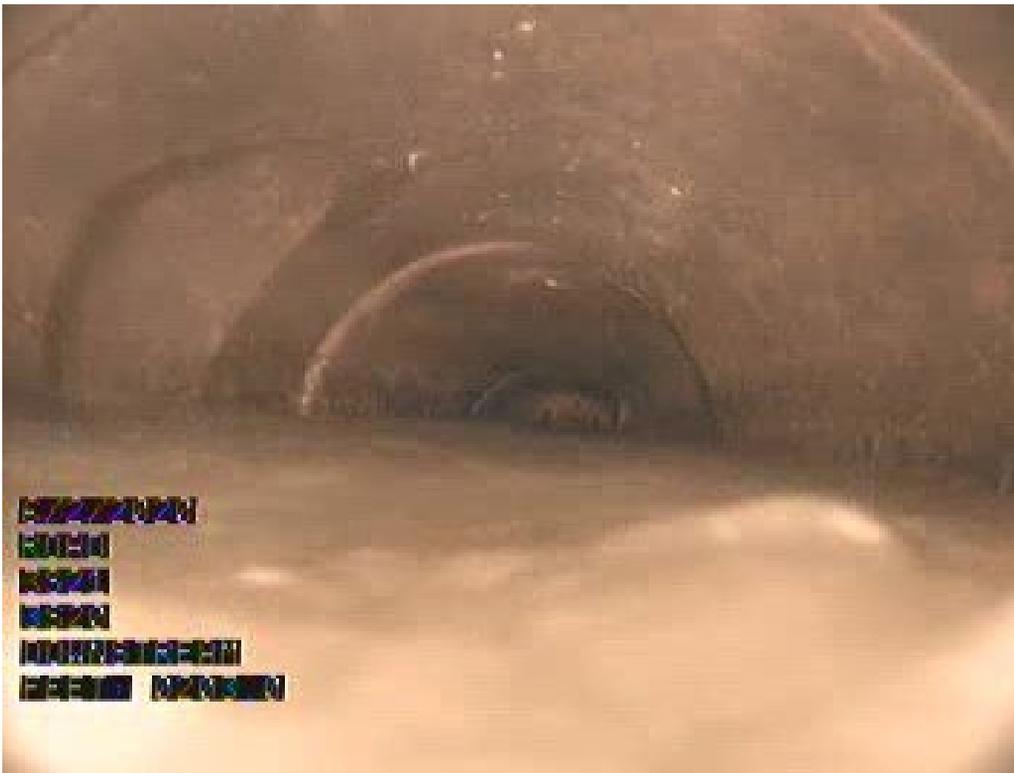
1561, 1585, 1577 Barrington

1577 Barrington Rd	5/19/2020	Hydraulic Restriction	A bad sag on 3S21:3S22 at 150' or so. Happened a couple additional times along surveyed lines, the sags seemed to coincide with where WIBs were the worst. The sags caused the pipe to go from about 20% capacity up to 50%-100% depending on location. Severely limited visibility. <b>•cause hydraulic deficiency because of Sag and possible flat slope</b> <b>•Pipe over 100 percent capacity during wet-weather.</b>
1585 Barrington Rd	5/19/2020	Hydraulic Restriction	A bad sag on 3S21:3S22 at 150' or so. Happened a couple additional times along surveyed lines, the sags seemed to coincide with where WIBs were the worst. The sags caused the pipe to go from about 20% capacity up to 50%-100% depending on location. Severely limited visibility. <b>•cause hydraulic deficiency because of Sag and possible flat slope</b>
1649 Grenoble Rd	Both	Roots	•Root ball just upstream of 2-77 <b>•cause roots</b>

SAG 220' downstream from manhole 3-21. **WIB** cause possibly hydraulic deficiency caused by sag and flat slope.

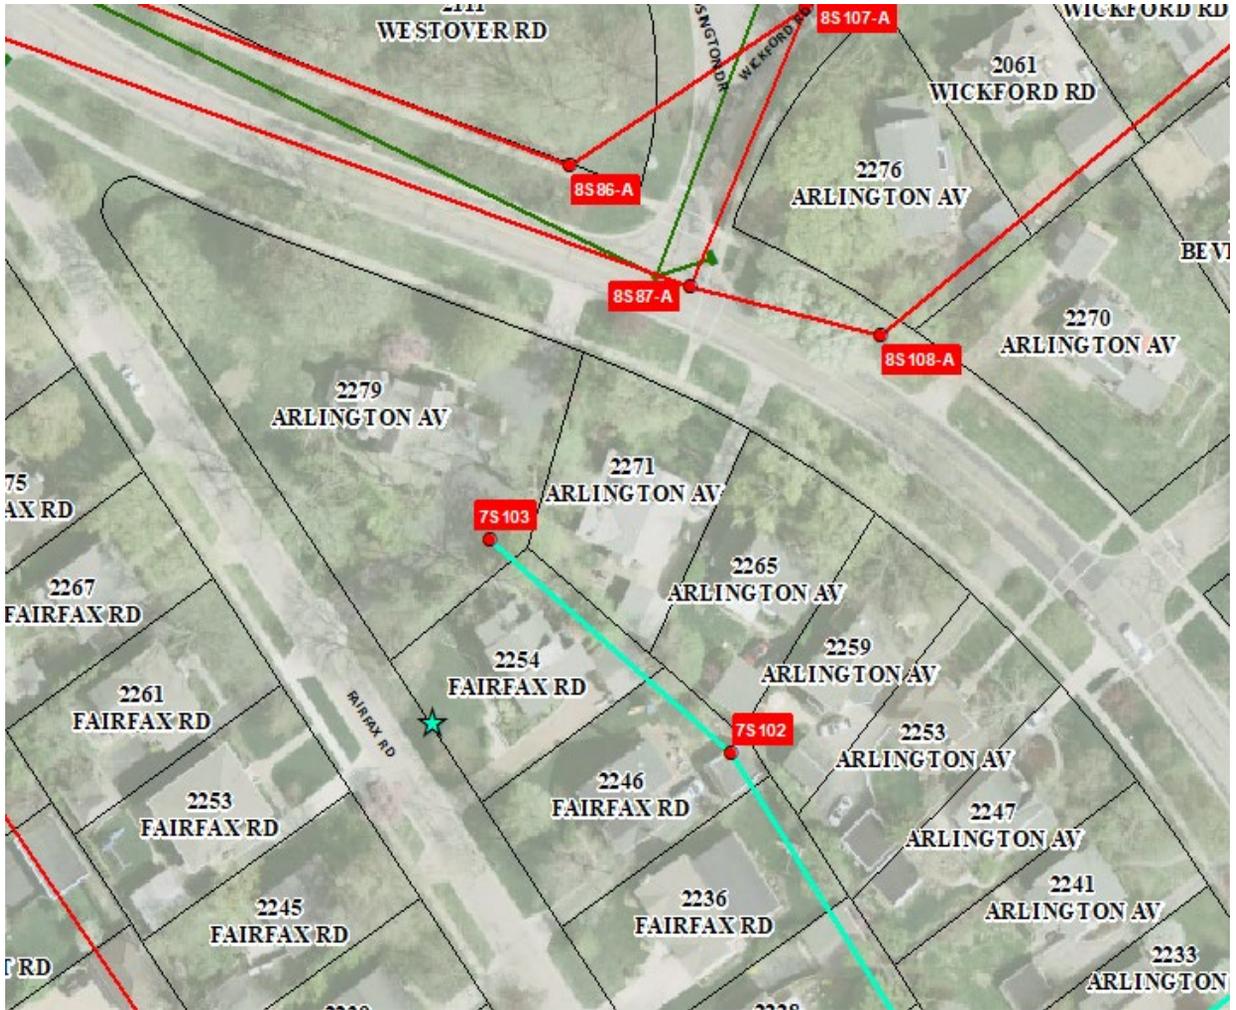
## 2254 Fairfax

Sewer Main Rehabilitated in 1992. Last home on upstream sewer section would suspect private lateral issue.

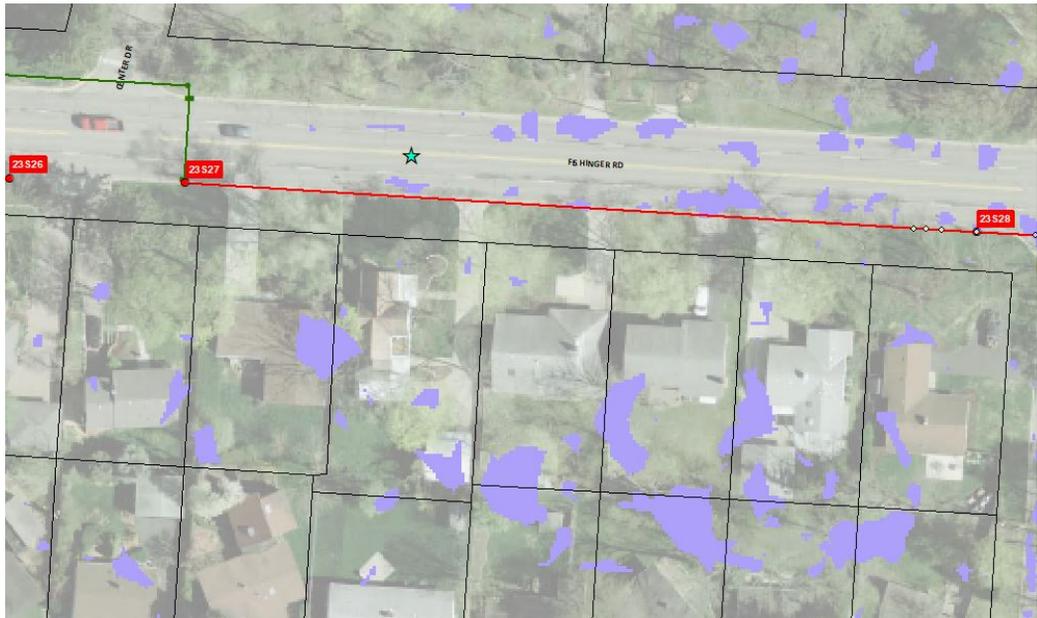
## 2459 Fishinger

23-27-28 inspection incomplete due to minor mineral deposits. **Nothing present that would cause backup and no significant ponding on property.**

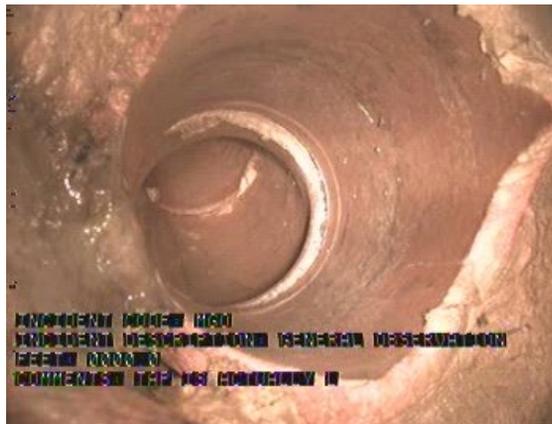
## 2566 Fishinger Road

Sewer very close proximity to stream with some localized ponding over sewer and lateral. Sewer main lined laterals not. 4 occurrences of I/I at tap/liner

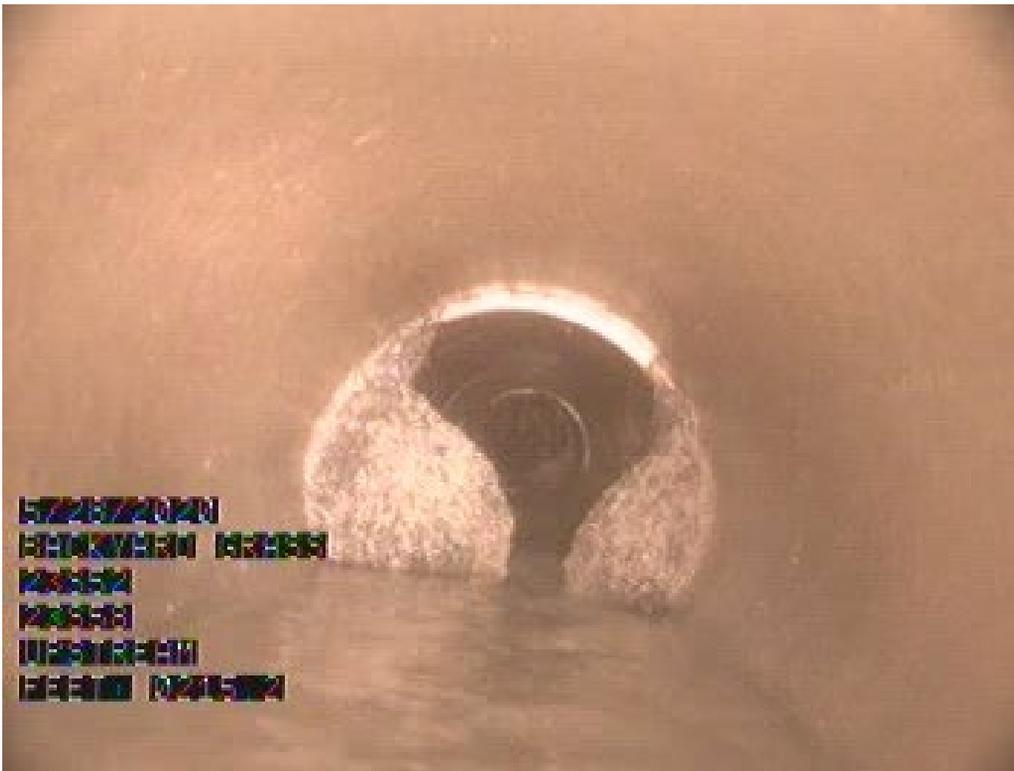
2150 Glenmere Rd.

Roots 150' downstream from 2150 Glenmere Road.  
**WIB cause possibly Roots.**

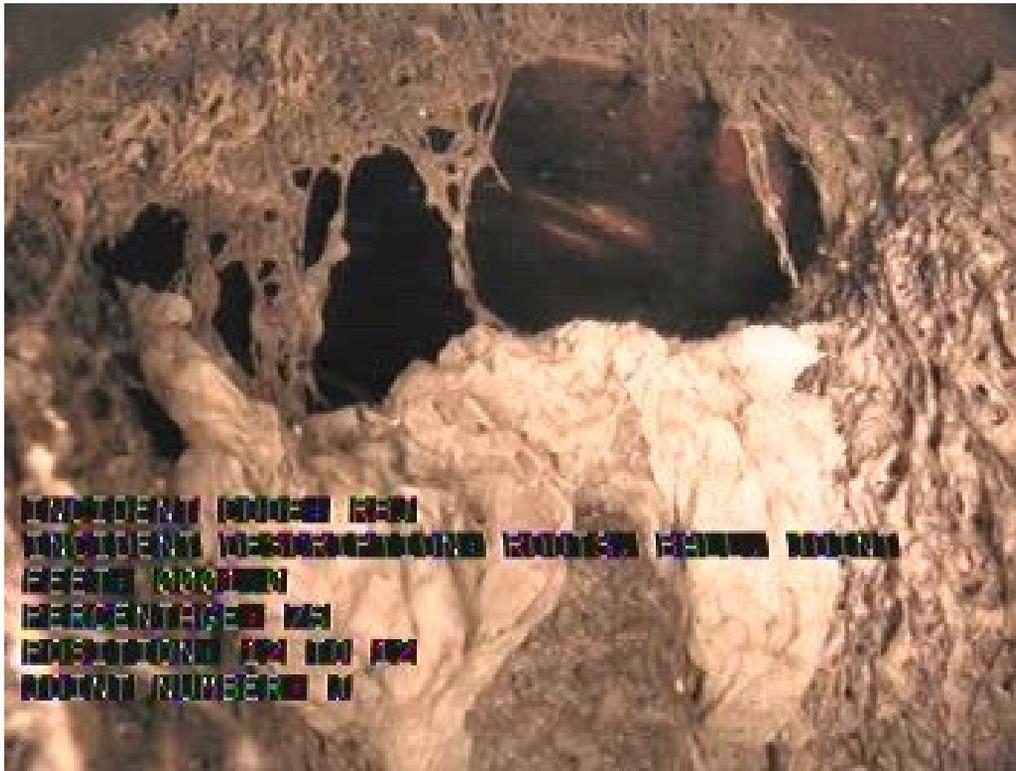
1649, 1665, 1681 Grenoble

Root ball just upstream of manhole 2-77. **WIB** cause possibly root ball.

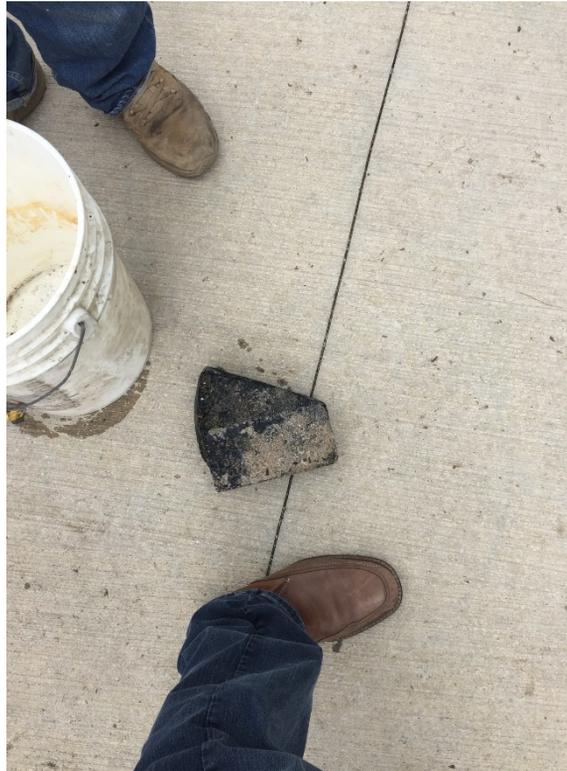
1787, 1797, 1817, 1833, 1841Inchcliff

Paver found in Tremont Sewer. **WIBs caused by paver obstruction in sewer .**

- Bolt Down Manholes - As previously identified, 33 WIBs occurred in the vicinity of Harwitch Rd., Kirkley Rd., Inchcliff Rd., and North Star Rd. due to very large rocks (boulders) and patio pavers. It is very likely that these obstructions were put in the sewers by individuals. To prevent this from happening in the future, the City should evaluate their system and replace existing sanitary manhole frames and lids with bolt down frames and lids in areas where large rocks and patio pavers were found and also near parks, streams and other facilities where children can play. Bolting the lids down will limit access to the sewers may not be obtained without the proper equipment. Installing bolt down lids was a successful alternative used by neighboring community Marble Cliff in locations where individuals were putting tree limbs and other debris in to the sewer causing overflows and WIBs.

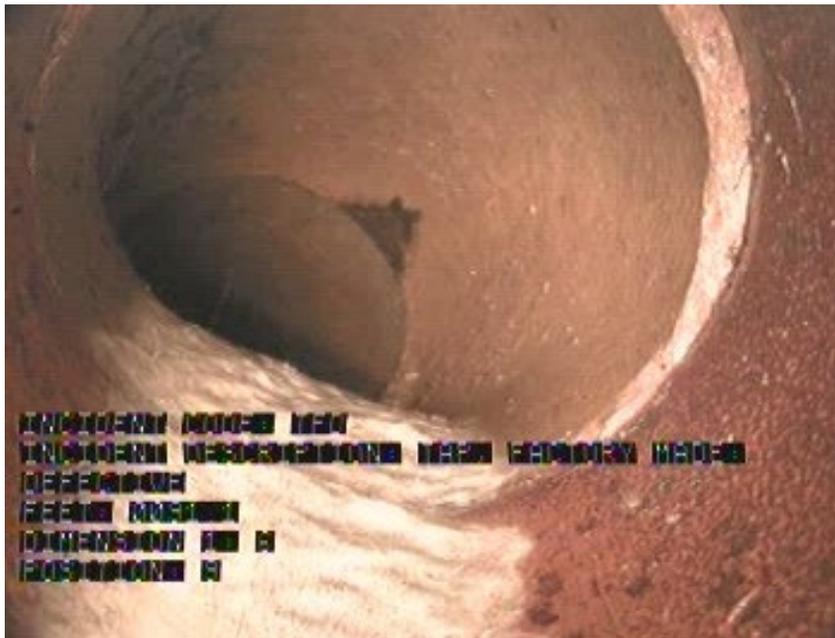
## 1930 Jervis

No observed issues that would cause backup  
3-minor occurrences of I/I. **Downstream  
Encrustacean and deposits could reduce sewer  
capacity.**

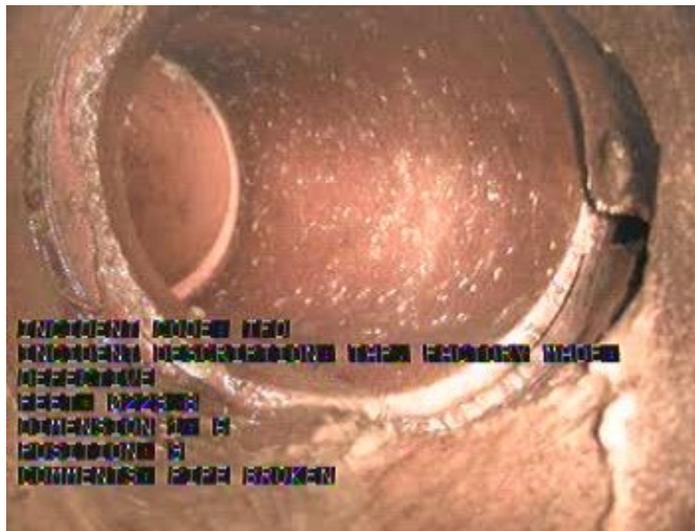
3750 Kioka Avenue

Sewer very close proximity to stream with significant surface ponding. Sewer lined laterals not. 4 occurrences of I/I at tap/liner interface. **Nothing present that would cause backup**

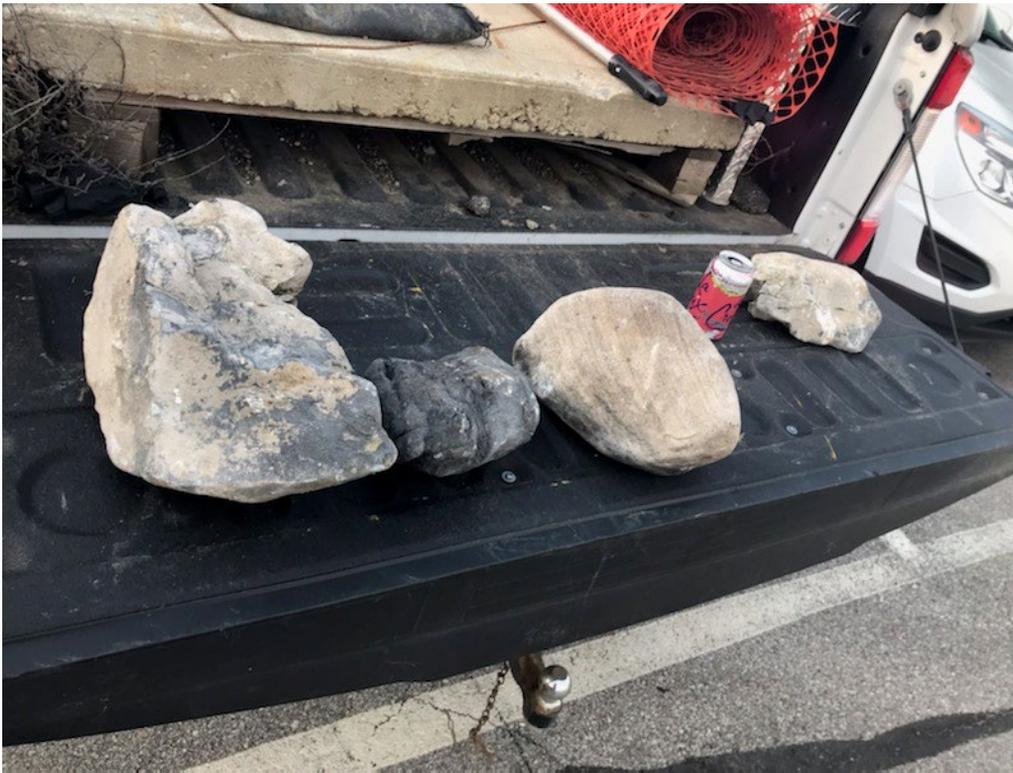
1335 Kirkley Road

Obstruction near manhole 4S126. **WIB** cause possibly rocks.

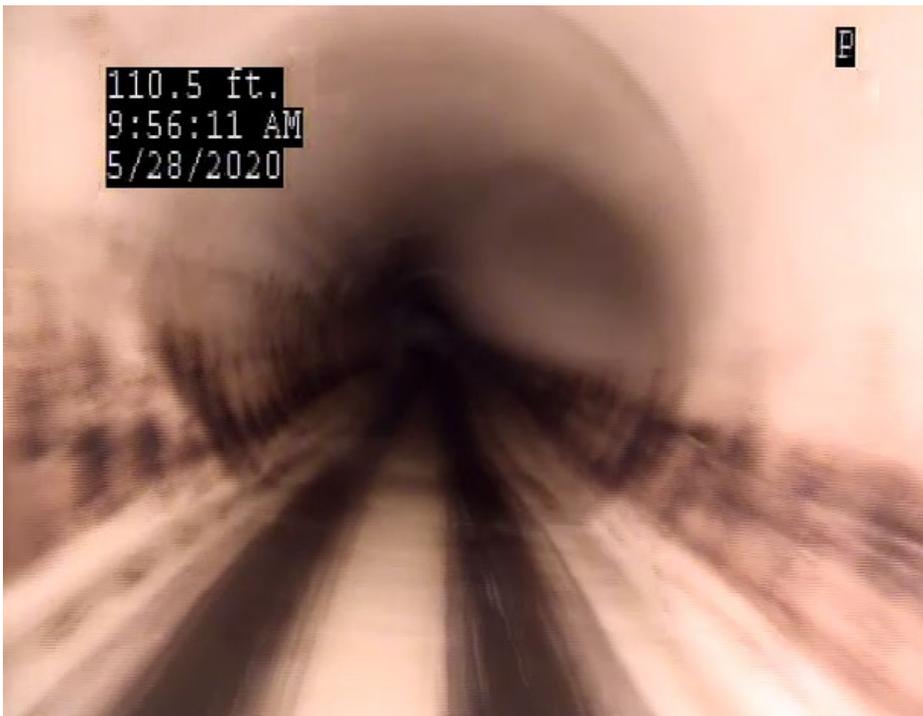
2651, 2723 NorthStar Rd.

Grit and settled deposits throughout the lines see the debris line stains in the picture above. **WIB cause possibly due to obstruction due to reduced capacity. Mainlines have been rehabilitated.**

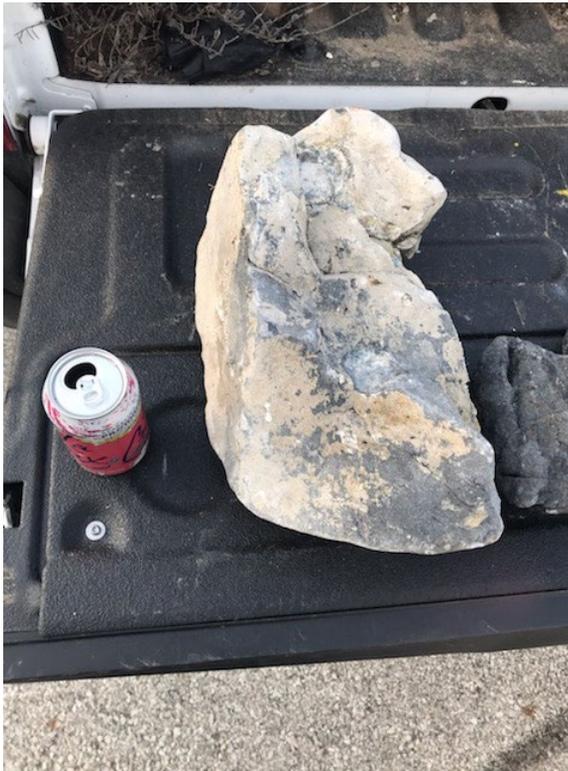
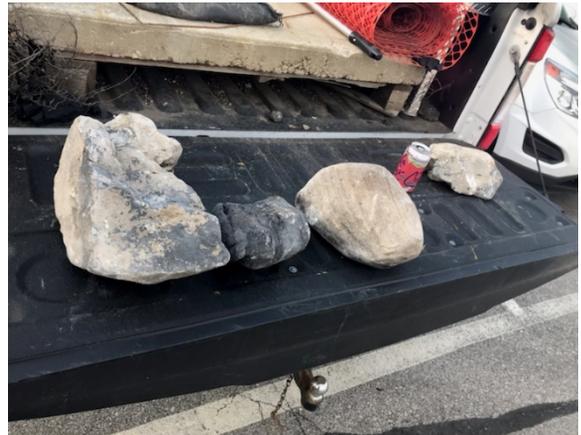
1335 Kirkley and 3154 NorthStar Rd.

Obstruction removed from 4-126:127. **WIB** cause by rock obstructions.

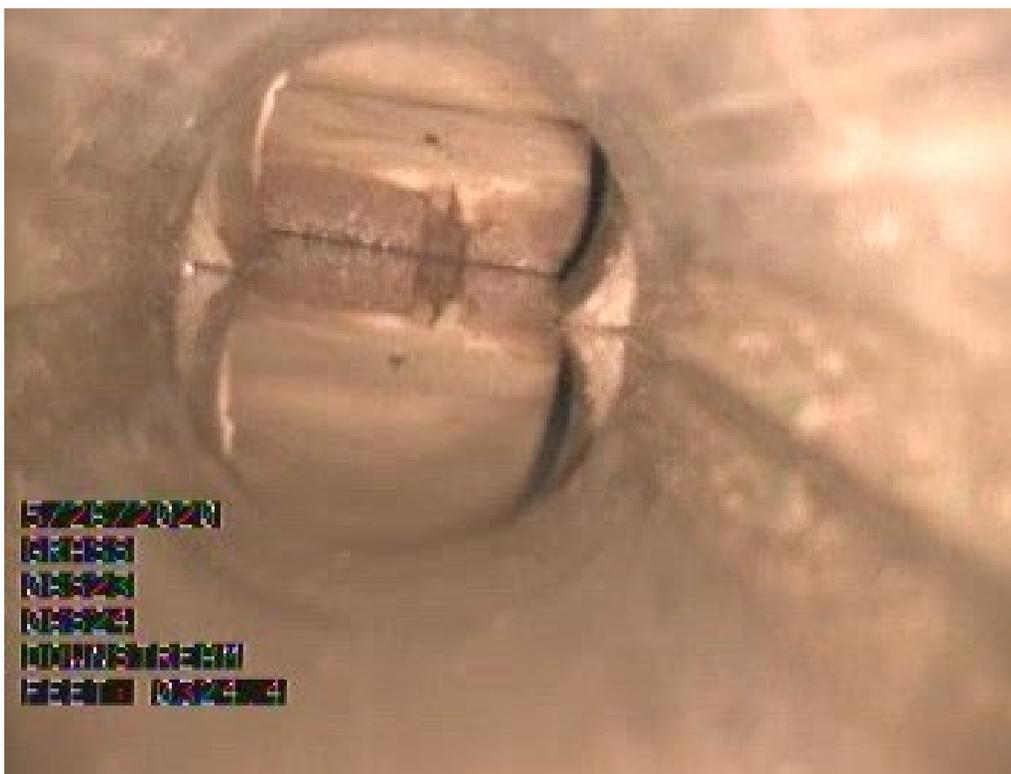
1771, 1804 Roxbury Road

Dropped repair upstream of Manhole 06-24. **WIB**  
**cause possibly hydraulic restriction.**

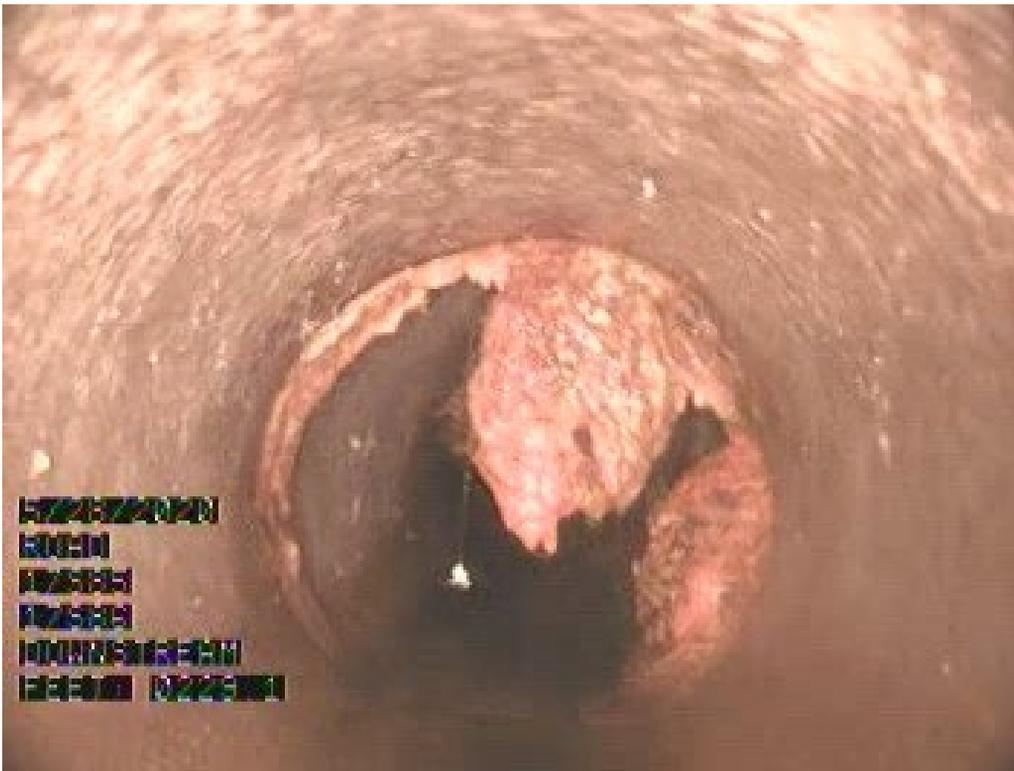
## 2176 Shrewsbury Road

59 occurrences of mineral deposit between 5% - 40%. **WIB cause possibly mineral deposit.**

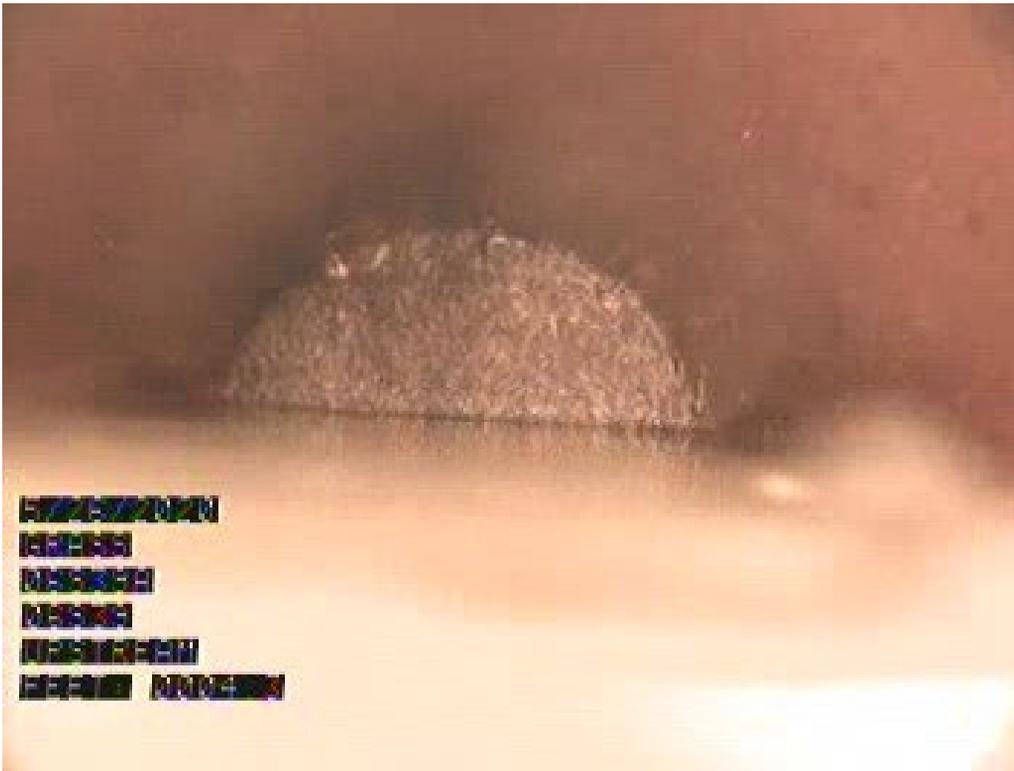
1956 Chelsea

Roots immediately upstream of manhole 6-39. **WIB**  
caused by **Roots**.

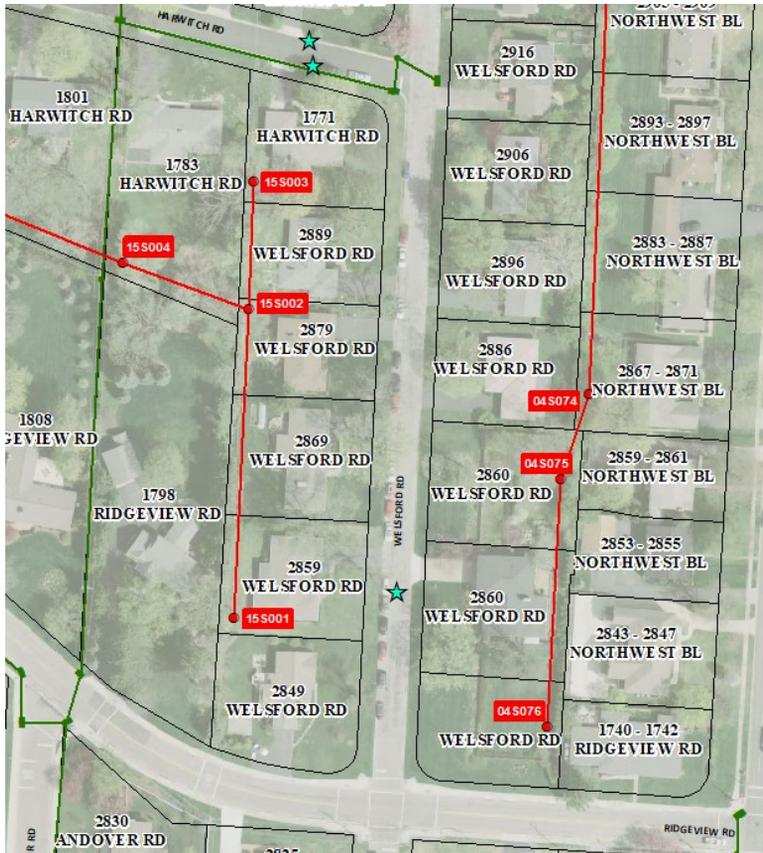
## 2859 Wellsford Rd.

Cause unknown, however is upstream of the Harwitch Road obstruction.

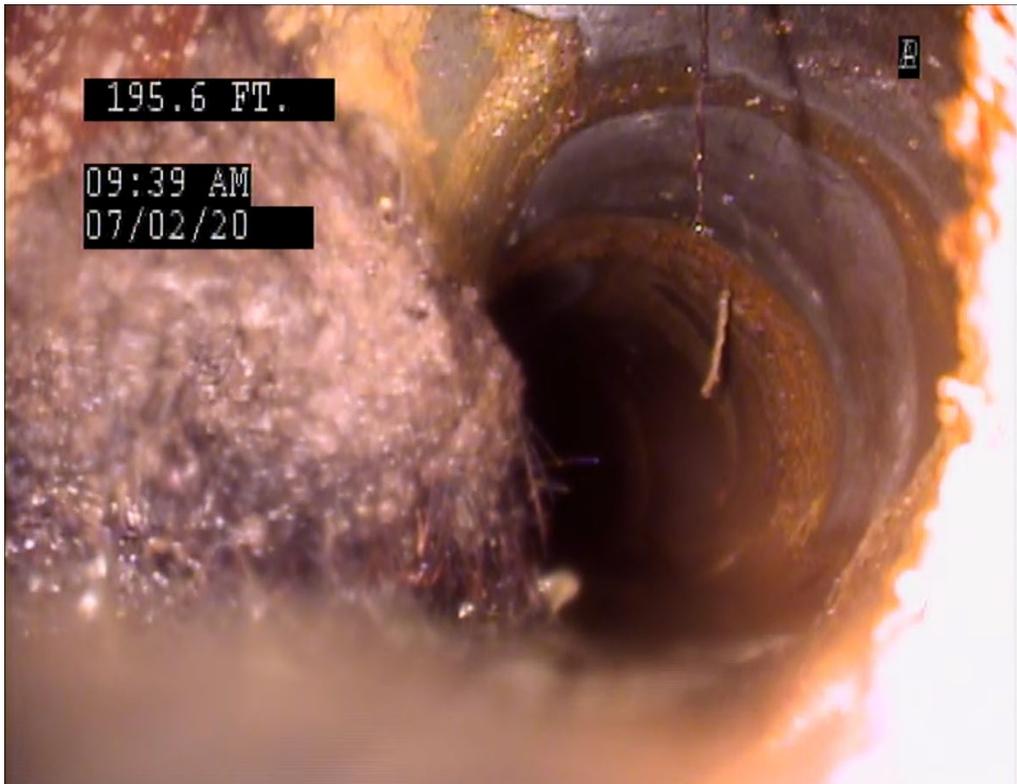
## 3139 Leeds Rd

Roots in lateral, 50% full sags ahead and behind lateral.  
Mainline lined in 2016.

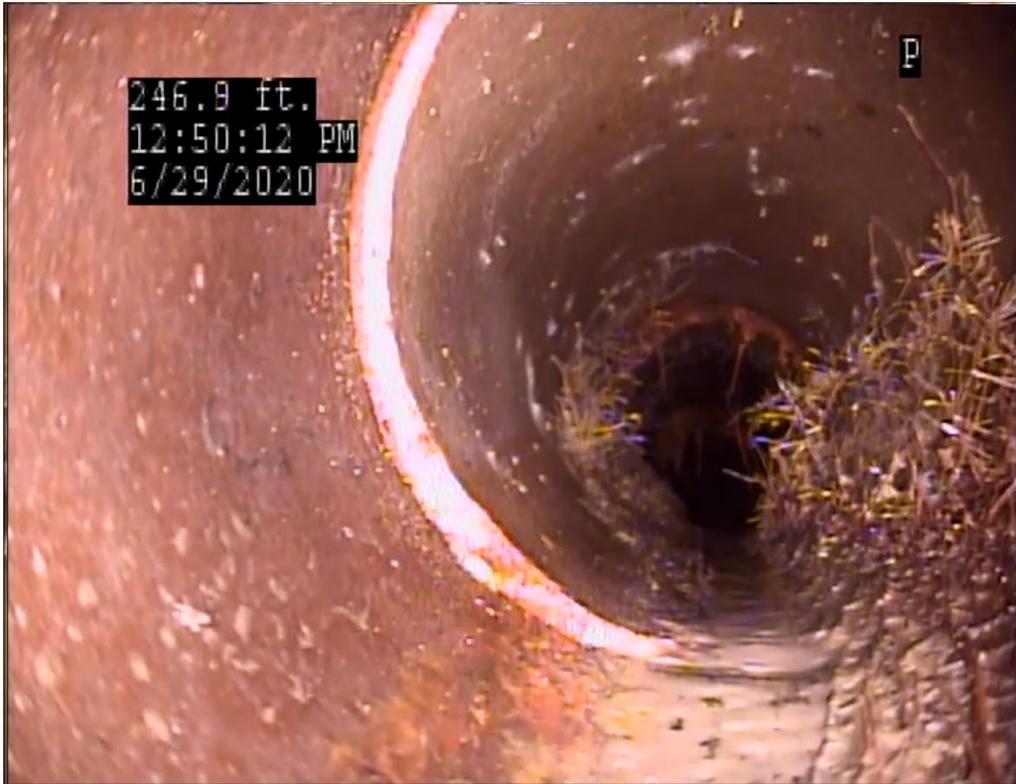
2624 Westmont Blvd

Some roots in lateral.

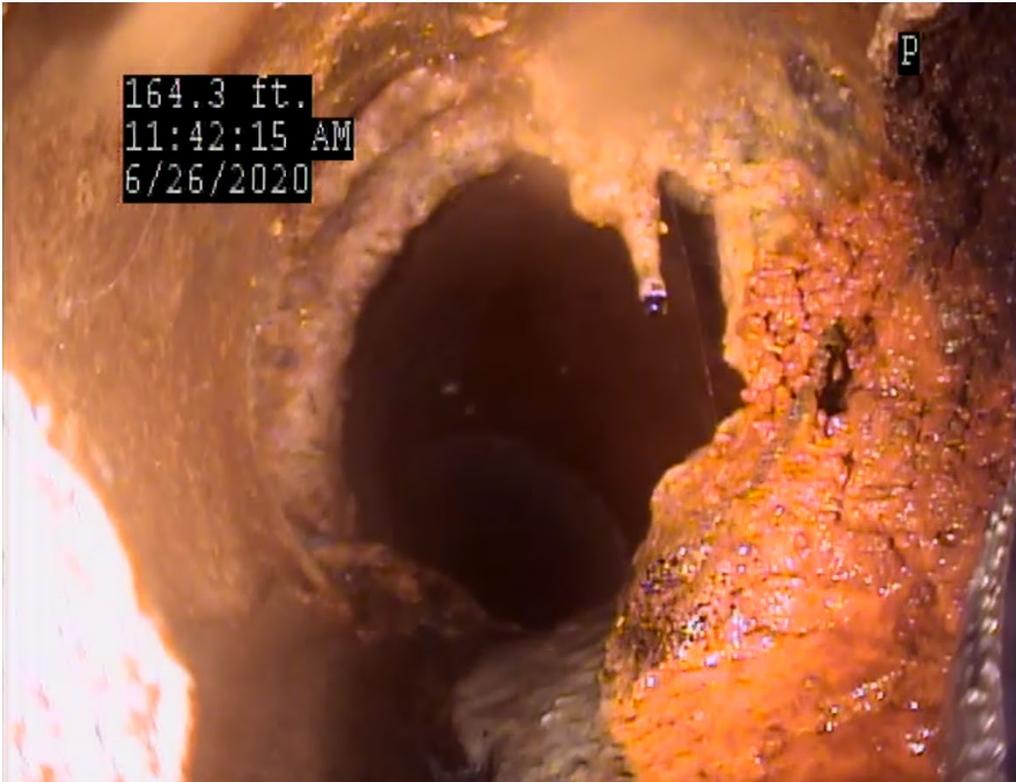
## 2738 Brandon Rd

Heavy deposits around lateral, mainline has moderate deposits and roots.

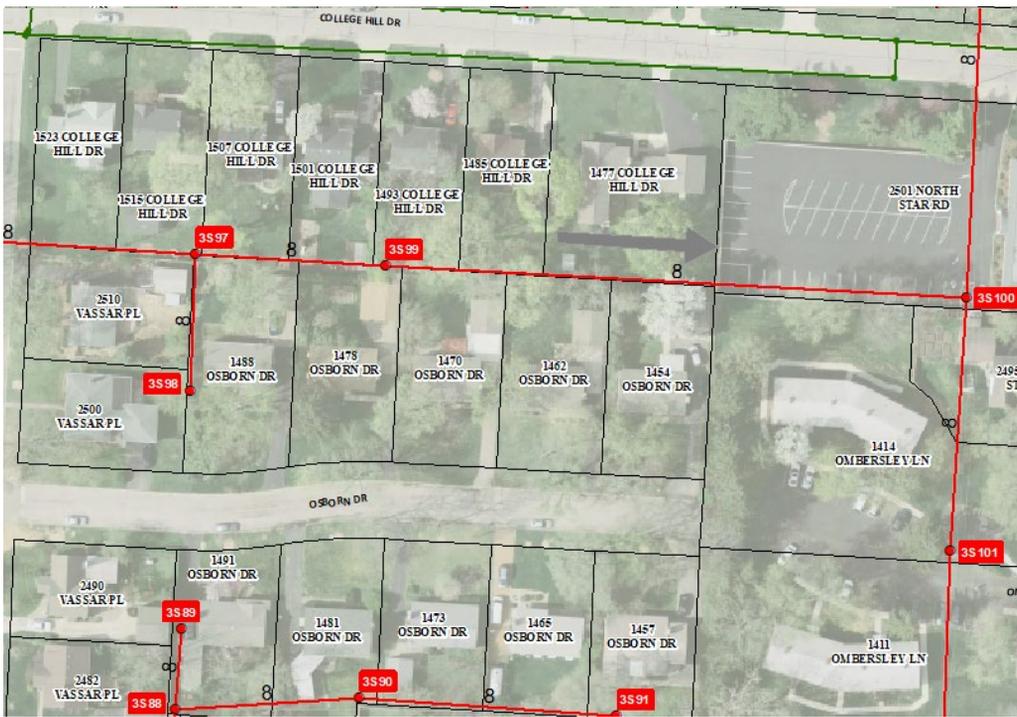
## 1462 Osborn Rd

Cause unknown, no reason for WIB visible in lateral or mainline.

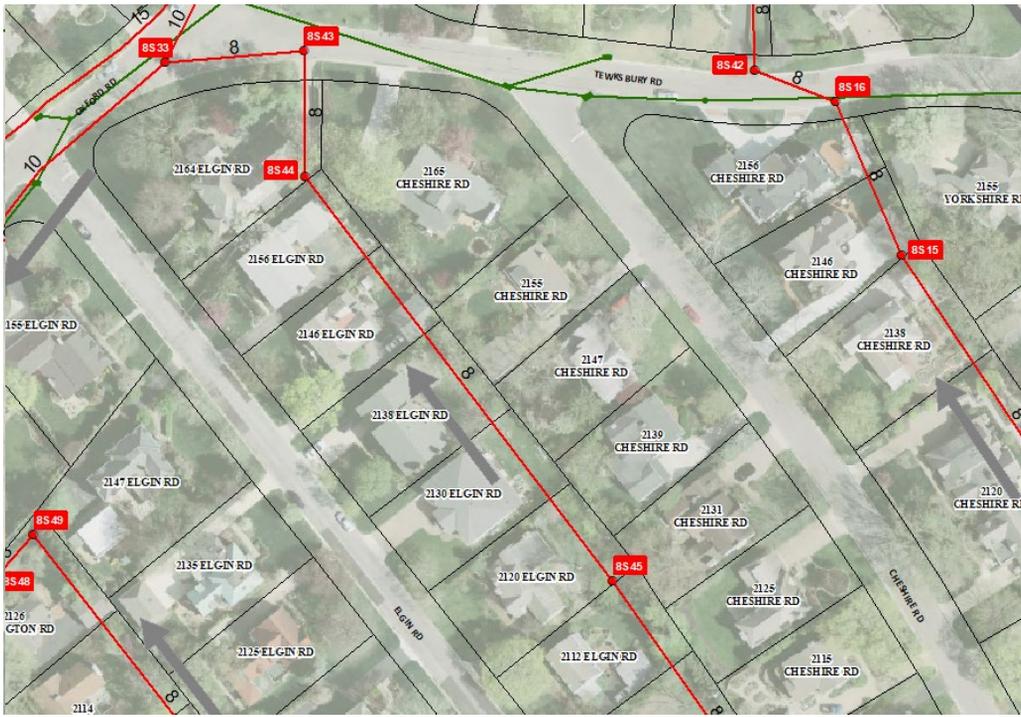
## 2138 Elgin Rd

Cause unknown, no reason for WIB visible in lateral or mainline.

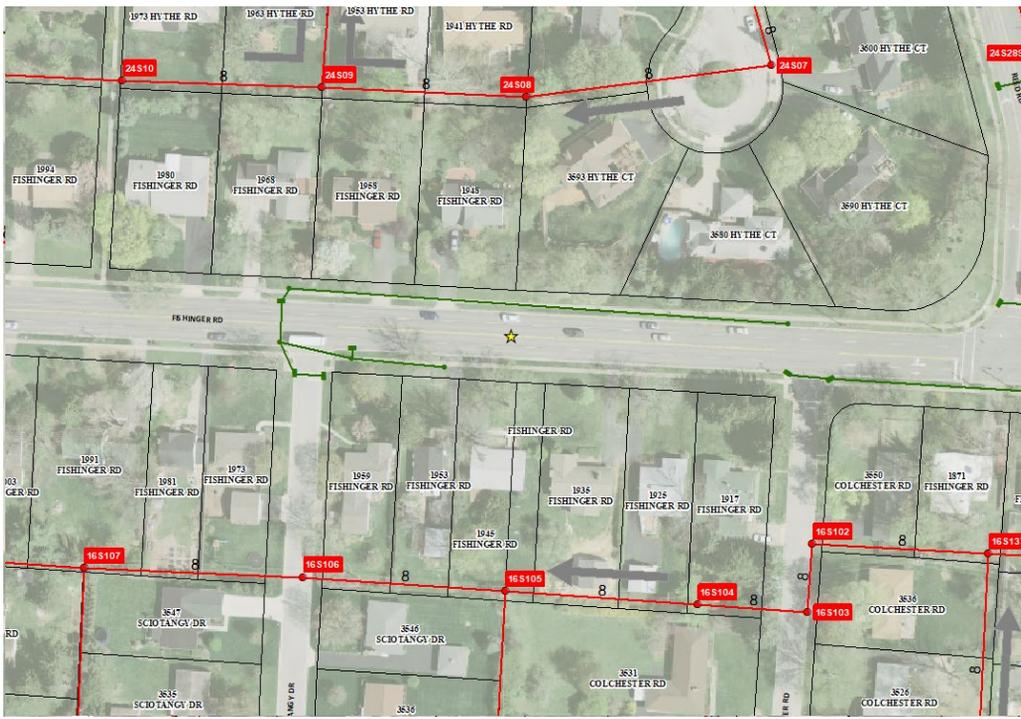
## 1945 Fishingier Rd

Cause unknown, no reason for WIB visible in lateral or mainline.

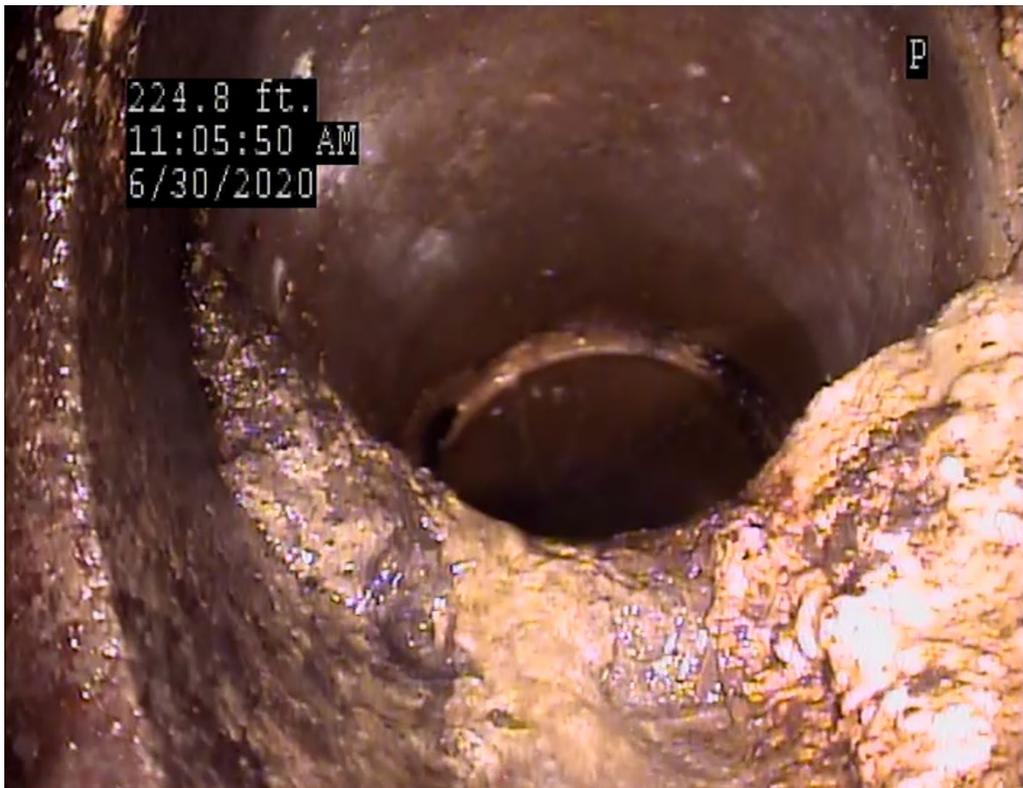
1465 Westminster Dr

Minor roots and ragging in lateral.
